THE HOME INSPECTION REPORT

21070401 - Client Last Name

123 Main Street, Sample City, NY 12345

07/04/2021 8:00 am - 11:00 am

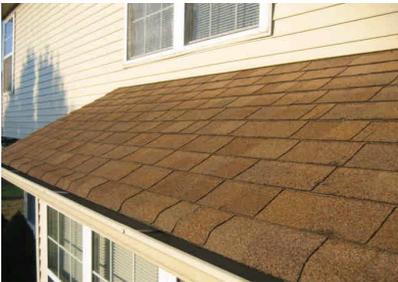
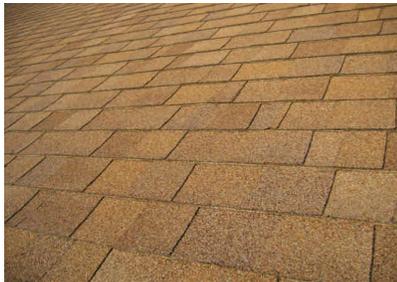
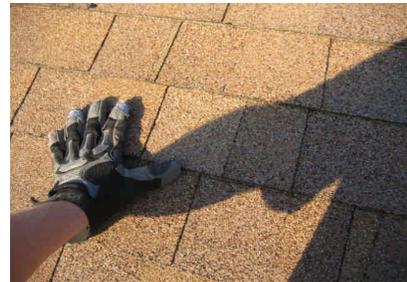
The asphalt shingle roof covering appears to be in good, functional condition. No major material defects. No major cracked, damaged, or missing shingles. Good. But this is not a guarantee against leaks in the future.

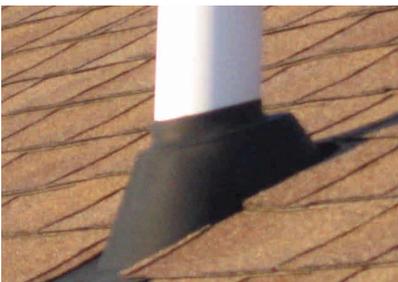
The flashing around the vent stacks coming through the roof appear to be in good condition. Good.

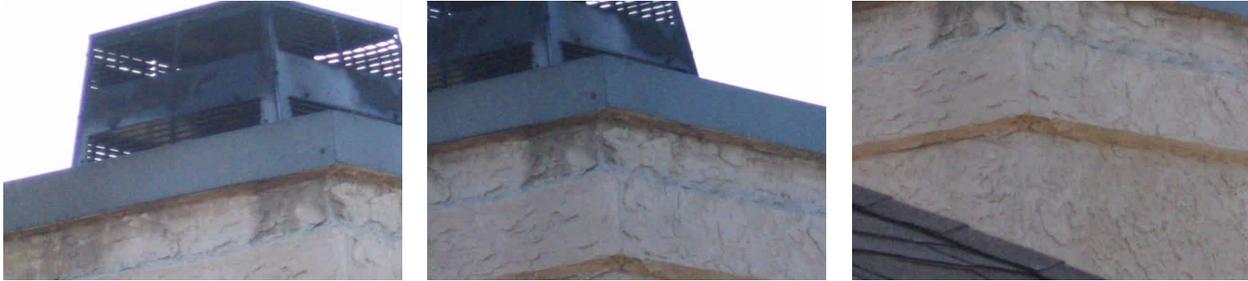
The chimney exterior sides appear to be in acceptable condition.

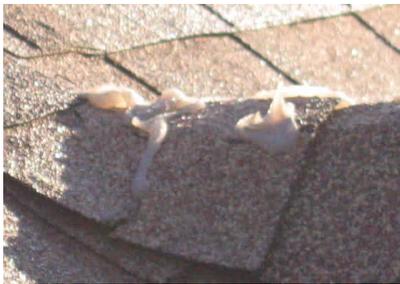
The chimney shingle flashing where the stack meets the roof is heavily sealed. Sealant is not permanent.

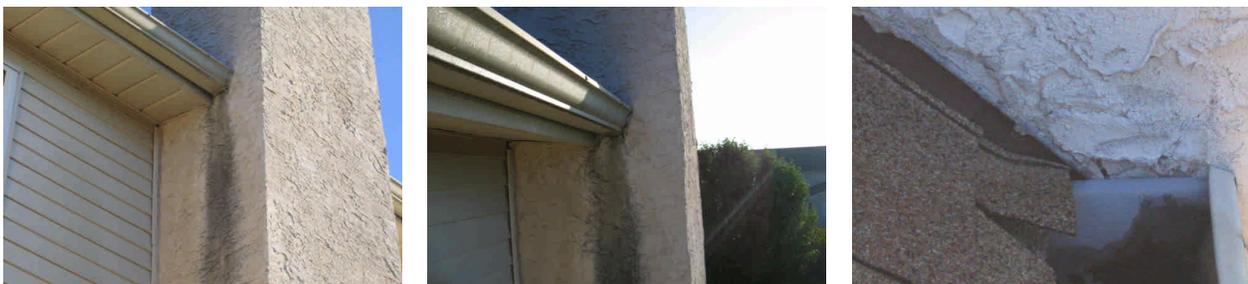
There is no kickout flashing used at the roof-to-wall intersection. Correction by a professional roofer is recommended. Located at the sides of the chimney stack. This may be allowing water draining off the roof to miss the gutter and drain behind the siding exterior covering. If not corrected, this could lead to water penetration and damage inside the wall. Kickouts also prevent water from streaking down the siding exterior covering and causing water stains. We recommend a kickout flashing - an angled piece of metal secured to the roof - to be installed near the bottom of the roof, to direct water into the gutter and away from this siding area.

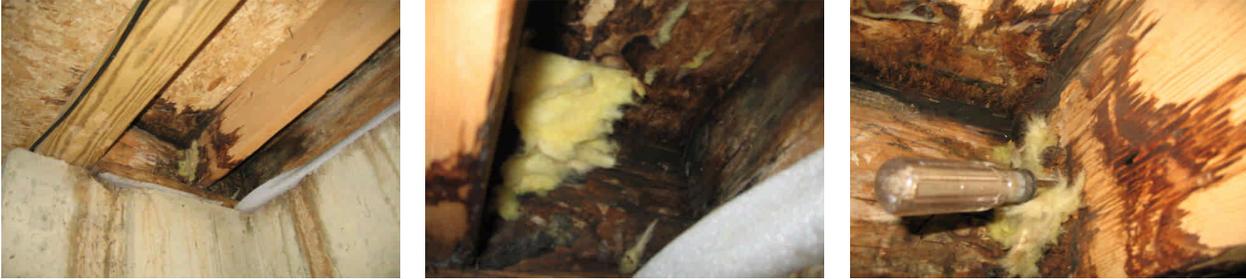
Major water damage visible from basement under the fireplace. Apparently caused by the missing flashing. Further evaluation of the structural integrity of the stack is recommended.

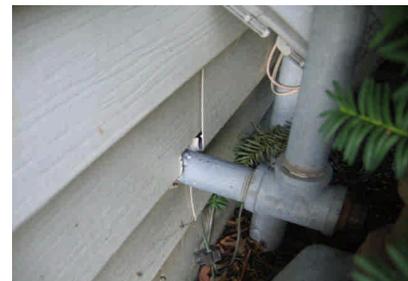
The main gas shut-off valve is located near the gas meter at the side of the house.

The gas meter has some surface rust on it.

Sealant needed around the gas line where it enters the house - minor.

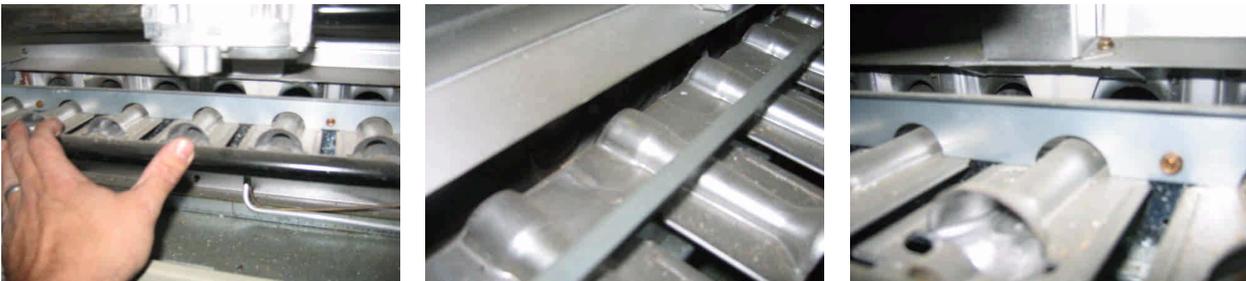
The gas burners of the heating system appear relatively clean. Good.

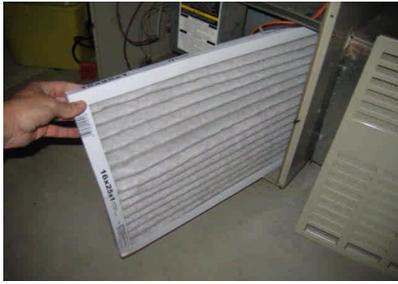
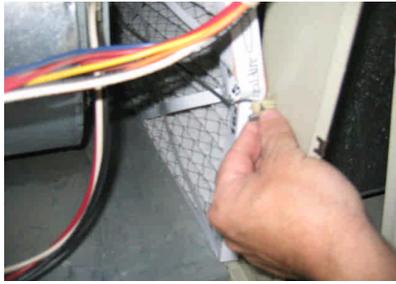
The air filter is disposable and clean. Good. Check the filter every 30 days. Replace when necessary.

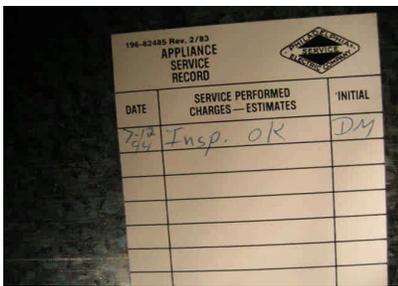
The last time the heating system was service has been recorded. Dated in 1994. The heating system should be serviced every year.

The heating system should be serviced every year by a HVAC professional technician. Make sure they record the service on a tag near the heating system, including date, name of technician, and what was done.

Recommend having the heating system inspected, cleaned, and serviced by an HVAC professional prior to closing.

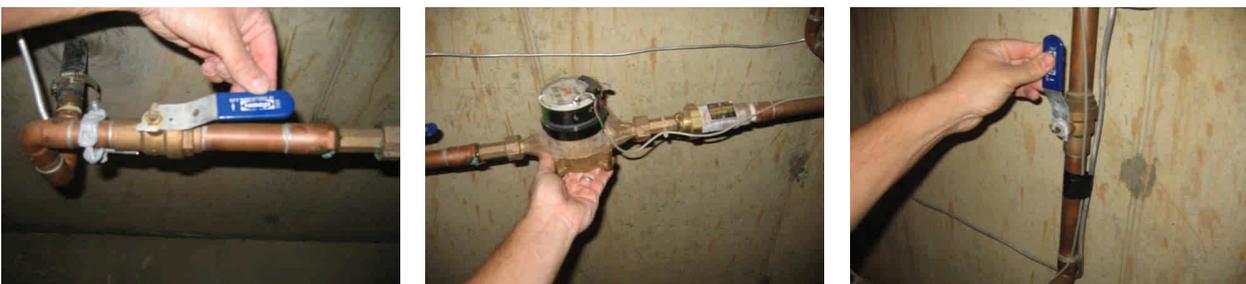
The main water shut-off valve is located in the basement.

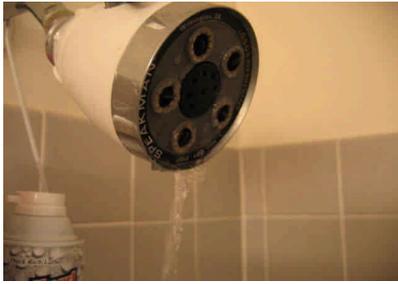
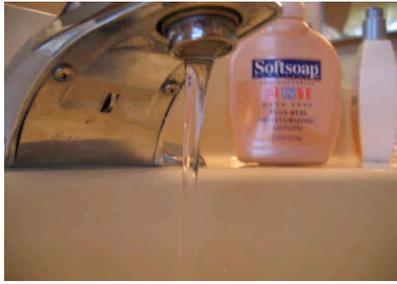
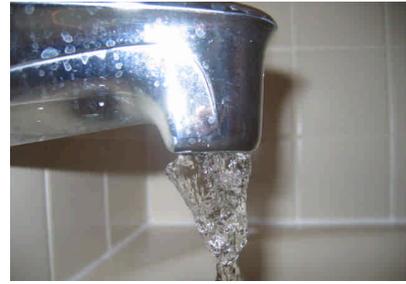
There is a noticeable low flow of hot water at the bathroom fixtures. Only one fixture can run hot water at a time. Further evaluation by a plumber is recommended.

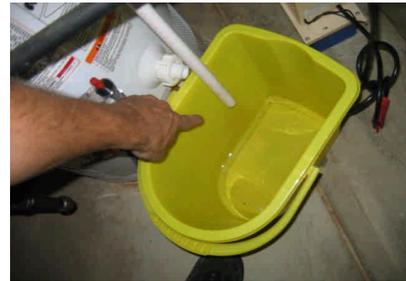
The relief valve on the hot water tank is actively leaking water into a bucket.

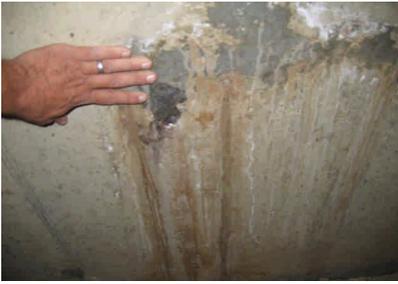
There are indications of previous ground water penetration through a foundation crack. Water marks. It has leaked in the past and may likely leak again in the future. Ask seller when the crack leaked in the past. Located at the left-side wall, near electrical panel.

Foundation cracks can be repaired using an epoxy ejection method. Epoxy ejection repairs are considered affordable and effective. Epoxy ejections make a bond between the cracked sections of the foundation that is actually stronger than the concrete itself. Further evaluation and correction to the foundation crack(s) by a professional (one familiar with epoxy injection repairs) is recommended.

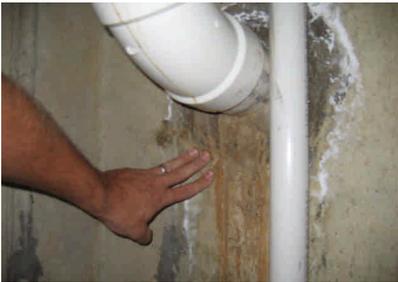
There are dry water marks around the sewer line. Located on the front wall.

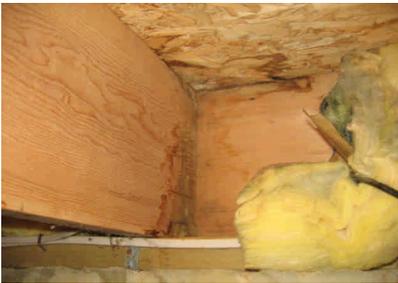
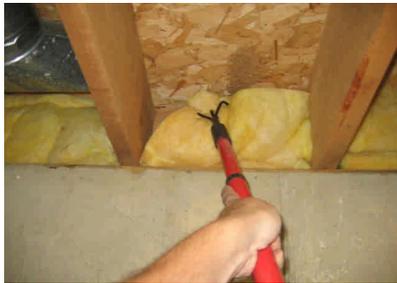
There are water stains in areas on the floor under the rear exterior door. Possible water problems in the past. Ask seller.

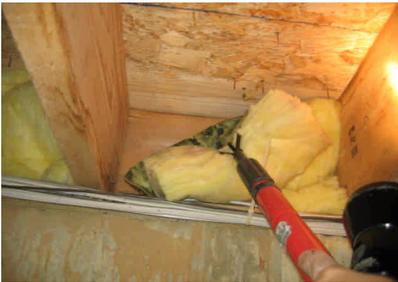
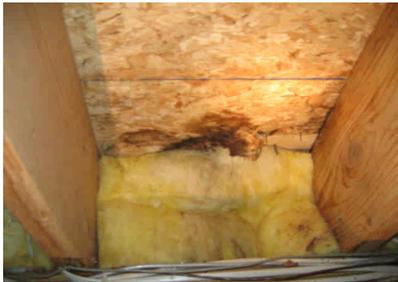
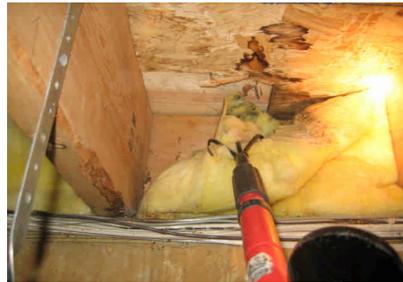
There have been structural repairs to floor under front entry door. Ask seller about prior repairs and possible water penetration problems.

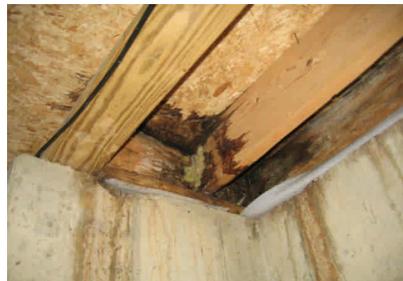
There is major water damage at floor components. Above the foundation wall. Located under the fireplace.

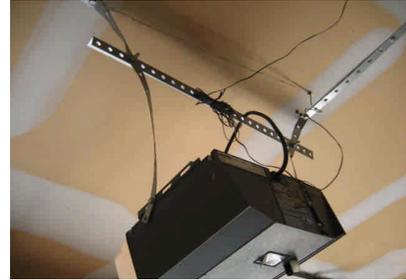
Each garage door opener is functional. With functional infra-red sensors.

The infra red auto-reversing sensor mechanisms are functional but located higher than the recommended six inches above grade.

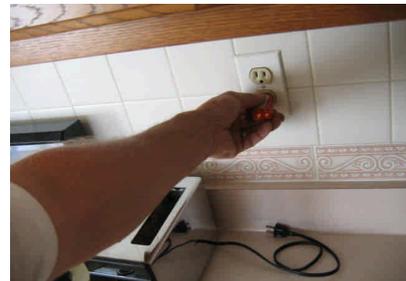
Missing GFCI-protection at the kitchen counter receptacles. All of the countertop and island receptacles should be upgraded to have ground fault GFCI protection, which is mandated by current standards and is an important safety feature. Right of stove.
